**Flood Control Project Maintenance  
Levee Inspections**  
**LMA District Cover Sheet**  
**Spring 2017 Levee Inspection Results**

**Reclamation District No. 0999 Netherlands**

**Spring 2017 Levee Inspection Results**

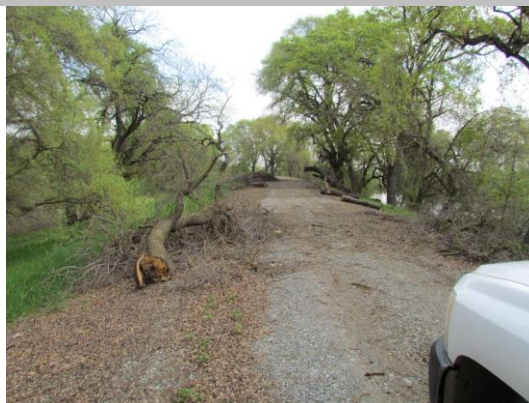
Photo 1 of 2 : SP\_2017\_RD0999\_236\_92\_20170324\_00248.jpg

LM Start	6.43	Rating **	U	Issue No.	92
LM End	6.48	Issue Type +	Ma	Location *	LS
Category	Earthen Levee			GPS Latitude/Longitude	
				Start	End
Item	Encroachments			38.391355 °	38.391776 °
				-121.540113 °	-121.539295 °
DWR ID	DWR_RD0999_05_s_2012_92				
Comment Code					
PR : Prunings					
Inspector Comment					
Large pruning piles and fallen tree on waterward and landward shoulder and slope.

Looking east at fallen tree and pruning on landward and waterward shoulder and slope.

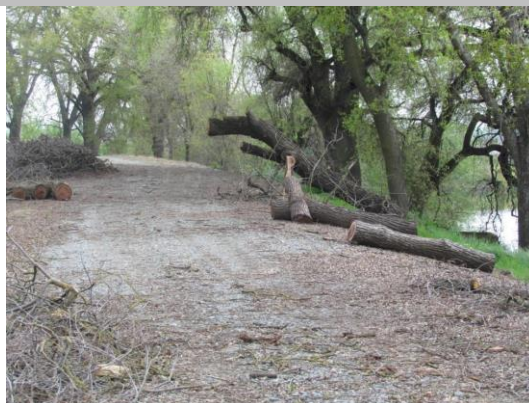
Photo 2 of 2 : SP\_2017\_RD0999\_236\_92\_20170324\_00249.jpg

Looking east at tree branches and limbs on waterward and landward shoulder and slope.

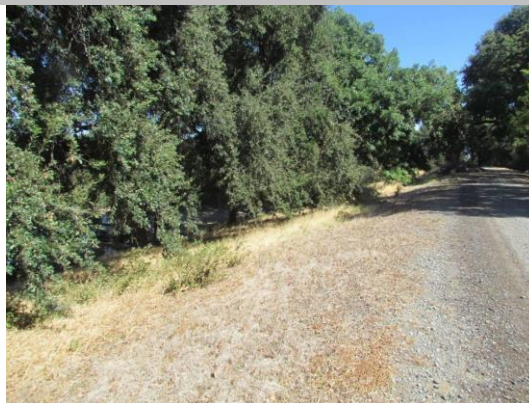
Photo 1 of 1 : SP\_2017\_RD0999\_236\_181\_20170314\_00124.jpg

LM Start	6.44	Rating **	U	Issue No.	181
LM End	6.44	Issue Type +	Ma	Location *	LS
Category	Earthen Levee			GPS Latitude/Longitude	
				Start	End
Item	Trim / Thin Trees			38.391502 °	38.391502 °
				-121.539897 °	-121.539897 °
DWR ID	DWR_RD0999_05_f_2015_181				
Comment Code					
T1 : Trim trees to at least five feet above ground level.					
Inspector Comment					
Untrimmed trees on landward slope and toe.

Looking northwest at untrimmed trees on landward slope and toe.

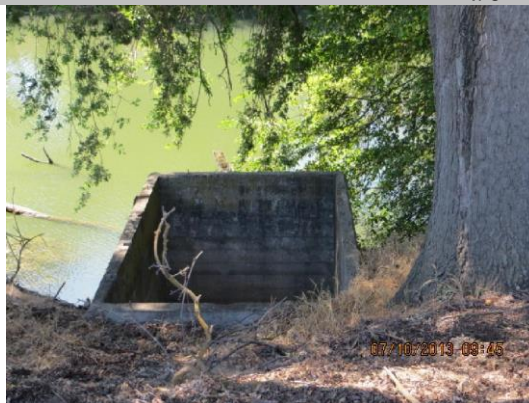
Photo 2 of 2 : UCIP\_SP\_2017\_15604\_25874.jpg

LM Start	6.47	Rating **	M	Issue No.	245 (cont)
LM End	6.47	Issue Type +	En	Location *	LS
Category	Supplemental			GPS Latitude/Longitude	
				Start	End
Item	DWR UCIP Field Study			38.391723 °	38.391723 °
				-121.539442 °	-121.539442 °
DWR ID					
Comment Code					
Inspector Comment					
FS_ID:15604 DS_ID:22860 EP_NO: N/A Repair Type: Non-Urgent Crossing Status: Found UCIP Comments: Pipe abandoned and should be done so properly. FIELD_STRUCT_DESC: *ABANDONED* 14-inch pipe through the levee 7.2 feet below the crown. Open 9'X14' concrete pump pit on waterward slope. Pipe has steel plate bolted over WS end . Originally included in the 1966 O&M manual. FS Date: 7/10/2013

Concrete pump pit on WS slope.

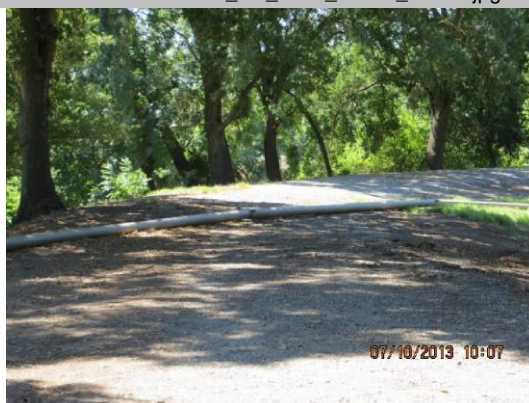
Photo 1 of 2 : UCIP\_SP\_2017\_16342\_27544.jpg

LM Start	6.56	Rating **	M	Issue No.	246	
LM End	6.56	Issue Type +	En	Location *	WS	
Category	Supplemental			GPS Latitude/Longitude		
				Start		End
Item	DWR UCIP Field Study			38.392788 °		38.392788 °
				-121.539047 °		-121.539047 °
DWR ID						
Comment Code						
Inspector Comment						
FS_ID:16342 DS_ID:23988 EP_NO: N/A Repair Type: Non-Urgent Crossing Status: Found UCIP Comments: Need to determine Permit No. for this crossing. FIELD_STRUCT_DESC: 8-inch aluminum irrigation pipe over the crown- pipe blocks crown when in use. Portable pump on WS toe. FS Date: 7/10/2013

Pipe at crossing over crown.

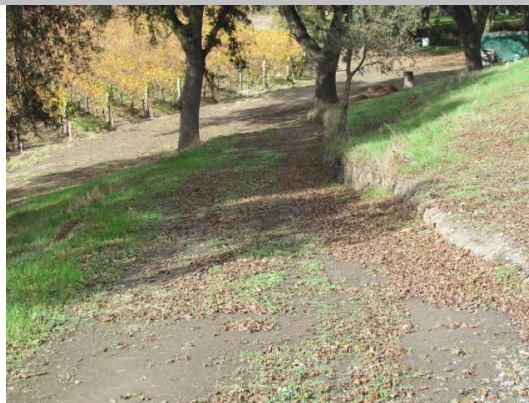
Photo 1 of 1 : SP\_2017\_RD0999\_236\_132\_20170314\_00090.jpg

LM Start	6.61	Rating **	M	Issue No.	132
LM End	6.61	Issue Type +	En	Location *	LS
Category	Earthen Levee			GPS Latitude/Longitude	
				Start	End
Item	Encroachments			38.393578 °	38.393578 °
				-121.539295 °	-121.539295 °
DWR ID	DWR_RD0999_05_f_2012_132				
Comment Code					
RA : Ramp					
Inspector Comment					
Landowner installed ramp on landside slope without permit.

Looking east at unauthorized ramp on landside slope.

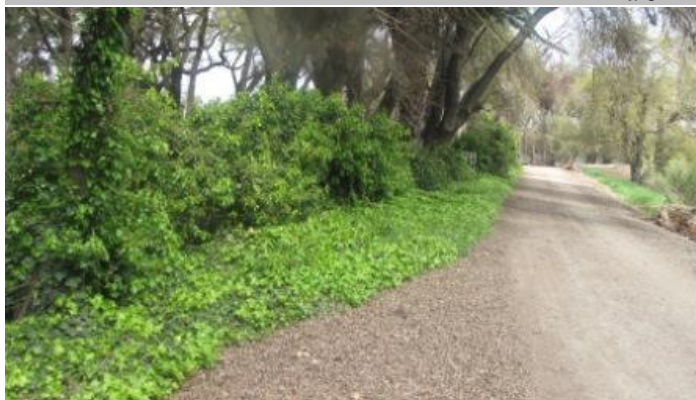
Photo 1 of 2 : SP\_2017\_RD0999\_236\_93\_20170314\_00071.jpg

LM Start	6.68	Rating **	U	Issue No.	93
LM End	6.71	Issue Type +	En	Location *	LS
Category	Earthen Levee			GPS Latitude/Longitude	
				Start	End
Item	Vegetation			38.394491 °	38.394991 °
				-121.539427 °	-121.539333 °
DWR ID	DWR_RD0999_05_s_2012_93				
Comment Code					
V6 : Landscaping					
Inspector Comment					
Dense landscaping on landward slope.

Looking north at overgrown landscape on landside slope and toe.

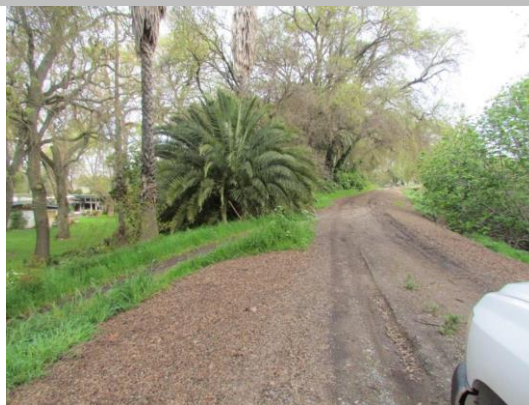
Photo 2 of 2 : SP\_2017\_RD0999\_236\_93\_20170324\_00250.jpg

LM Start	<b>6.68</b>	Rating **	U	Issue No.	<b>93 (cont)</b>
LM End	<b>6.71</b>	Issue Type +	En	Location *	LS

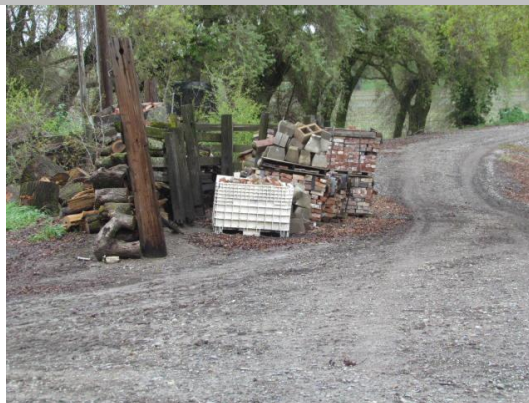
Photo 2 of 4 : SP\_2017\_RD0999\_236\_96\_20170314\_00073.jpg

LM Start	6.73	Rating **	M	Issue No.	96 (cont)	
LM End	6.73	Issue Type +	En	Location *	LS	
Category	Earthen Levee			GPS Latitude/Longitude		
				Start		End
Item	Encroachments			38.395234 °		38.395234 °
				-121.539323 °		-121.539323 °
DWR ID	DWR_RD0999_05_s_2012_96					
Comment Code						
MA : Material						
Inspector Comment						
Firewood and other material on landside shoulder.

Looking northeast at firewood and other material on landside shoulder.  
(Spring 2012)

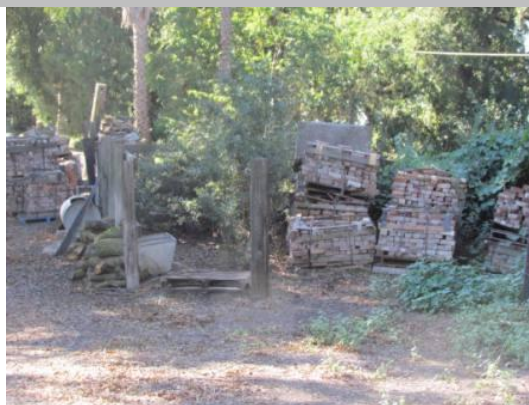
Photo 3 of 4 : SP\_2017\_RD0999\_236\_96\_20170314\_00074.jpg

Looking south at firewood and other material on landside shoulder and crown.

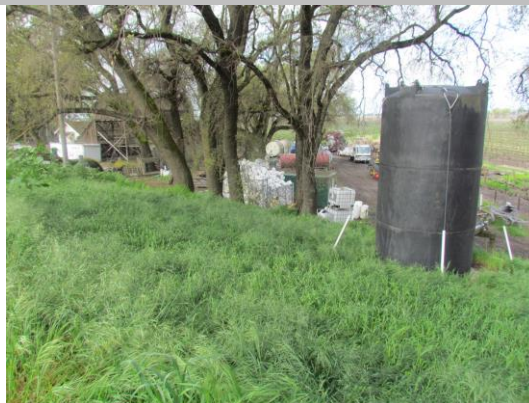
Photo 1 of 2 : SP\_2017\_RD0999\_236\_226\_20170327\_00251.jpg

LM Start	6.77	Rating **	U	Issue No.	226
LM End	6.77	Issue Type +	En	Location *	LS
Category	Earthen Levee			GPS Latitude/Longitude	
				Start	End
Item	Encroachments			38.395723 °	38.395723 °
				-121.539052 °	-121.539052 °
DWR ID	DWR_RD0999_05_s_2017_226				
Comment Code					
TA : Tank					
Inspector Comment					
Large water tank on landward slope and other material.

Looking west at water tank on landward slope.

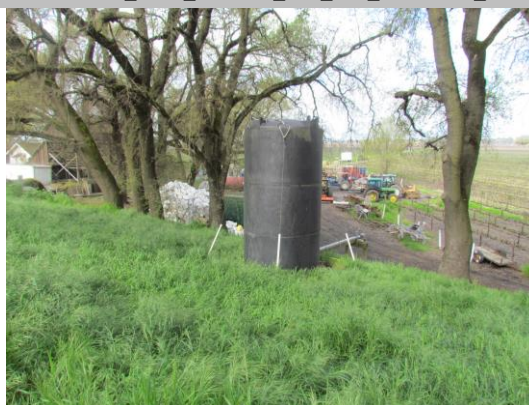
Photo 2 of 2 : SP\_2017\_RD0999\_236\_226\_20170327\_00252.jpg

Looking west at water tank on landward slope and toe.

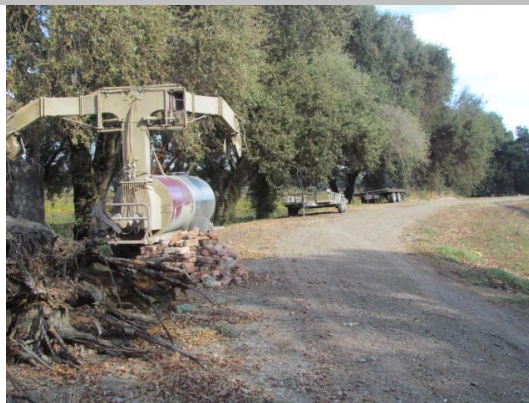
Photo 1 of 3 : SP\_2017\_RD0999\_236\_156\_20170314\_00105.jpg

Looking north at farm equipment on landward shoulder (Fall 2014)

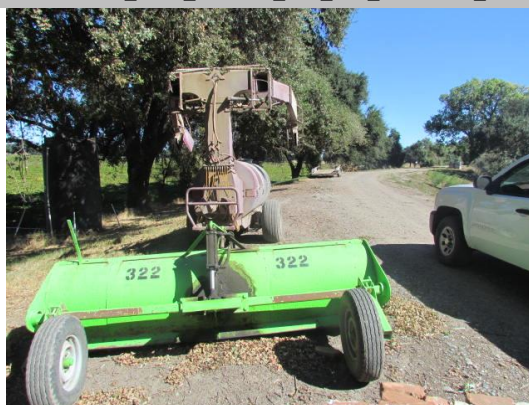
Photo 2 of 3 : SP\_2017\_RD0999\_236\_156\_20170314\_00106.jpg

Looking north at farm equipment on landward shoulder.

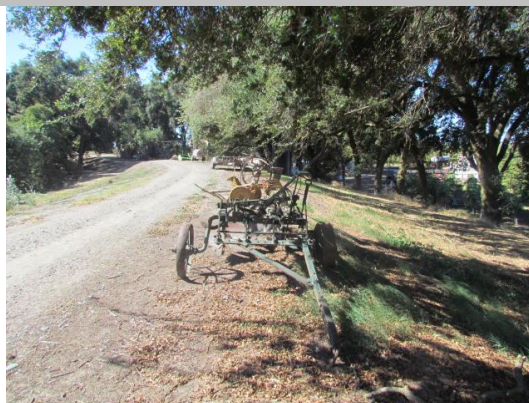
Photo 3 of 3 : SP\_2017\_RD0999\_236\_156\_20170314\_00107.jpg

Looking south at farm equipment on landward shoulder.

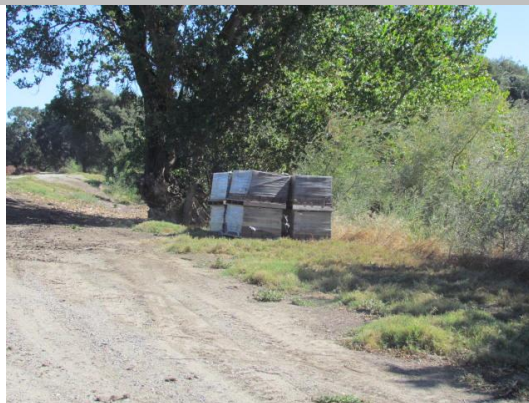
Photo 1 of 1 : SP\_2017\_RD0999\_236\_157\_20170314\_00108.jpg

LM Start	6.80	Rating **	M	Issue No.	157
LM End	6.80	Issue Type +	En	Location *	WS
Category	Earthen Levee			GPS Latitude/Longitude	
				Start	End
Item	Encroachments			38.396099 °	38.396099 °
				-121.538585 °	-121.538585 °
DWR ID	DWR_RD0999_05_f_2013_157				
Comment Code					
MA : Material					
Inspector Comment					
Landowner is storing pallets of bricks on waterward shoulder.

Looking northeast at pallets of bricks stored on waterward shoulder.

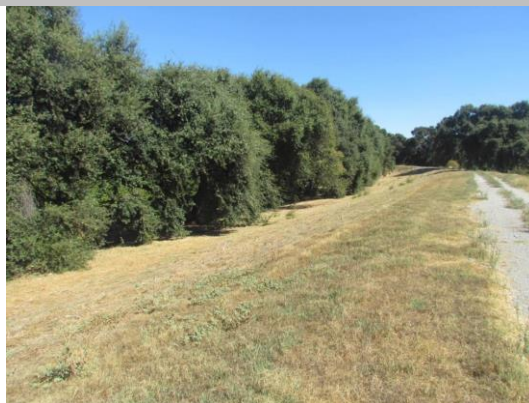
Photo 1 of 1 : SP\_2017\_RD0999\_236\_204\_20170314\_00144.jpg

LM Start	6.85	Rating **	U	Issue No.	204
LM End	7.49	Issue Type +	Ma	Location *	LS
Category	Earthen Levee			GPS Latitude/Longitude	
				Start	End
Item	Trim / Thin Trees			38.396379 °	38.403600 °
				-121.537814 °	-121.540311 °
DWR ID	DWR_RD0999_05_f_2014_204				
Comment Code					
T1 : Trim trees to at least five feet above ground level.					
Inspector Comment					
Trees at landward toe blocking visibility.

Looking northwest at dense trees at landward toe.

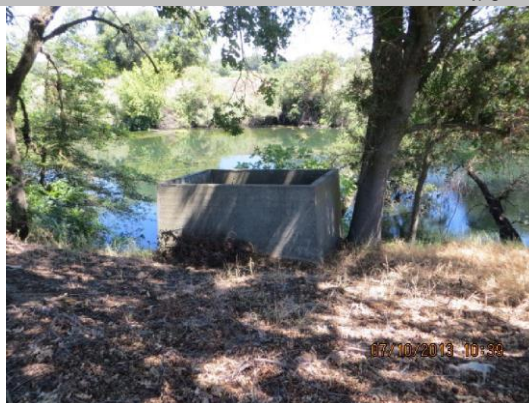
Photo 1 of 3 : UCIP\_SP\_2017\_50096\_25938.jpg

Comment Code					
Inspector Comment					
FS_ID:50096 DS_ID:22863 EP_NO: N/A Repair Type: Urgent Crossing Status: Found UCIP Comments: 07/07/2016 - Pipe abandoned and appears to be open inside the concrete box on the WS shoulder. No appurtenances visible from the LS. (T. Hatch/UCIP)07/10/2013 - Pipe abandoned and open on both ends. Concrete pump pit foundation undermined at WS toe. Pipe should be abandoned properly (W. Wylie/UCIP) FIELD_STRUCT_DESC: *ABANDONED* 14-inch steel irrigation pipe through the levee, 4.8 feet below the crown. 9 foot by 14 foot concrete pump pit on waterside (WS) slope. Pipe open on WS inlet to pump pit. O&M Manual indicates pipe is abandoned and 16-inch in diameter [Additional Reference(s): DWR Levee Logs, 1992. USACE Sacramento O&M Manual 113 Revised, October 1966 (LM 7.60)]. FS Date: 7/7/2016

Concrete pump pit on WS toe.

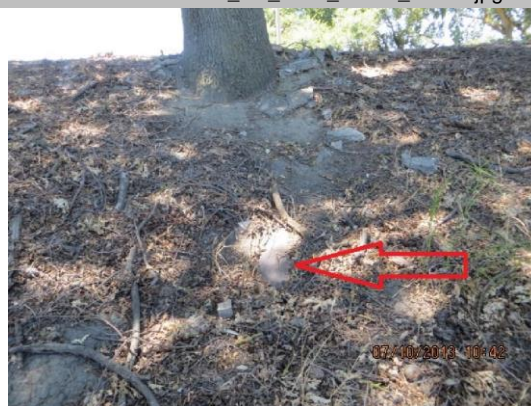
Photo 2 of 3 : UCIP\_SP\_2017\_50096\_25937.jpg

FS\_ID:50096  
DS\_ID:22863  
EP\_NO: N/A  
Repair Type: Urgent  
Crossing Status: Found  
UCIP Comments: 07/07/2016 - Pipe abandoned and appears to be open inside the concrete box on the WS shoulder. No appurtenances visible from the LS. (T. Hatch/UCIP)07/10/2013 - Pipe abandoned and open on both ends. Concrete pump pit foundation undermined at WS toe. Pipe should be abandoned properly (W. Wylie/UCIP)  
FIELD\_STRUCT\_DESC: \*ABANDONED\* 14-inch steel irrigation pipe through the levee, 4.8 feet below the crown. 9 foot by 14 foot concrete pump pit on waterside (WS) slope. Pipe open on WS inlet to pump pit. O&M Manual indicates pipe is abandoned and 16-inch in diameter  
[Additional Reference(s): DWR Levee Logs, 1992. USACE Sacramento O&M Manual 113 Revised, October 1966 (LM 7.60)].  
FS Date: 7/7/2016

Pipe visible on WS slope.

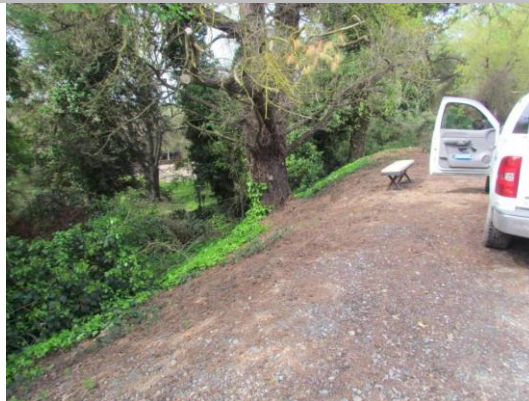
Photo 1 of 2 : SP\_2017\_RD0999\_236\_66\_20170327\_00253.jpg

Looking east at landscaping at bottom half of levee. (Spring 2017)

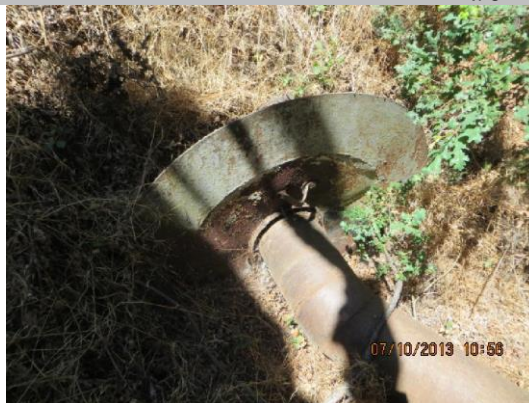
Photo 1 of 3 : UCIP\_SP\_2017\_15624\_25969.jpg

LM Start	7.57	Rating **	M	Issue No.	248
LM End	7.57	Issue Type +	En	Location *	LS
Category	Supplemental			GPS Latitude/Longitude	
				Start	End
Item	DWR UCIP Field Study			38.403993 °	38.403993 °
				-121.541626 °	-121.541626 °
DWR ID					
Comment Code					
Inspector Comment					
FS_ID:15624					
DS_ID:22864					
EP_NO: N/A					
Repair Type: Non-Urgent					
Crossing Status: Found					
UCIP Comments: Annular space needs to be grouted between the 12 and 14-inch pipes.					
FIELD_STRUCT_DESC: 14-inch steel irrigation pipe through the levee 7.0 feet below the crown. 12-inch pipe sleeved through 14-inch pipe.					
Annular space not grouted. 36-inch concrete standpipe on LS toe.					
Originally included in the 1966 O&M manual.					
FS Date: 7/10/2013

12-inch pipe sleeved through 14-inch pipe at WS slope. Erosion around pipe on levee slopes-both sides of levee.

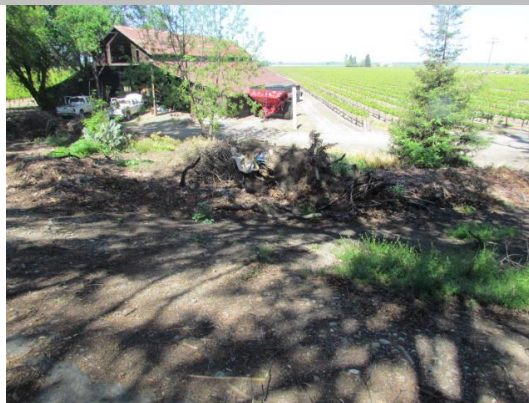
Photo 1 of 1 : SP\_2017\_RD0999\_236\_185\_20170314\_00125.jpg

LM Start	8.03	Rating **	M	Issue No.	185
LM End	8.03	Issue Type +	En	Location *	LS
Category	Earthen Levee			GPS Latitude/Longitude	
				Start	End
Item	Encroachments			38.409324 °	38.409324 °
				-121.541223 °	-121.541223 °
DWR ID	DWR_RD0999_05_s_2015_185				
Comment Code					
PR : Prunings					
Inspector Comment					
Garbage within prunings piles.

Looking west at pruning piles on landward slope. (Spring 2015)

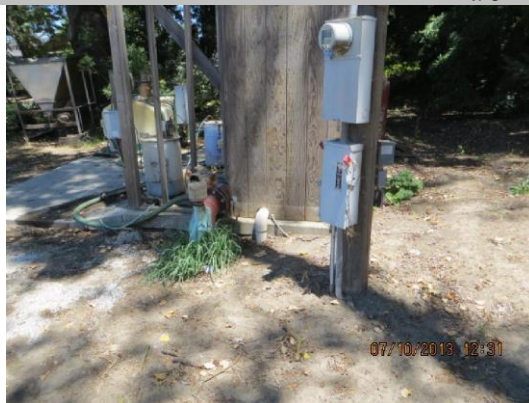
Photo 2 of 3 : UCIP\_SP\_2017\_15683\_26101.jpg

LM Start	8.04	Rating **	M	Issue No.	251 (cont)	
LM End	8.04	Issue Type +	En	Location *	LS	
Category	Supplemental			GPS Latitude/Longitude		
				Start		End
Item	DWR UCIP Field Study			38.409421 °		38.409421 °
				-121.541007 °		-121.541007 °
DWR ID						
Comment Code						
Inspector Comment						
FS_ID:15683						
DS_ID:22881						
EP_NO: 13463						
Repair Type: Non-Urgent						
Crossing Status: Found						
UCIP Comments: Pipe exposed in excavation on LS shoulder at what may be a leak.						
FIELD_STRUCT_DESC: 12-inch pipe through the levee 2.5-feet below the crown. Pump on pile structure with walkway on WS toe. 12-inch PVC standpipe on LS toe next to filter plant and shed. (Permit No. 13463, 1982). 1.5-inch PVC electrical conduit at same location. This pipe replaced an existing 8-inch pipe that was grouted in place.						
FS Date: 7/10/2013

Air vent and butterfly valve at filter plant/shed. Meter on JP with electrical controls.

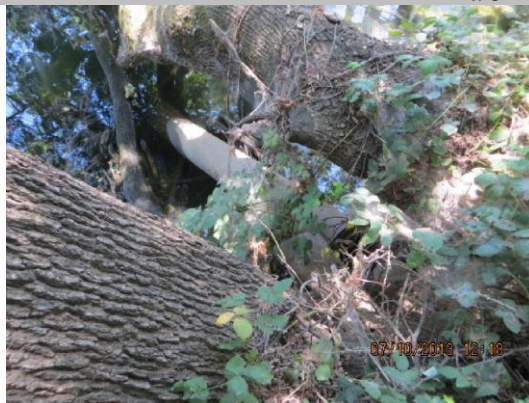
Photo 1 of 3 : UCIP\_SP\_2017\_15663\_26082.jpg

LM Start	8.05	Rating **	M	Issue No.	252
LM End	8.05	Issue Type +	En	Location *	LS
Category	Supplemental			GPS Latitude/Longitude	
				Start	End
Item	DWR UCIP Field Study			38.409440 °	38.409440 °
				-121.540928 °	-121.540928 °
DWR ID					
Comment Code					
Inspector Comment					
FS_ID:15663 DS_ID:22868 EP_NO: N/A Repair Type: Non-Urgent Crossing Status: Found UCIP Comments: Pipe abandoned and should be done so properly. FIELD_STRUCT_DESC: *Abandoned* 14-inch pipe through levee 14.4 feet below crown. Gate valve at pump in Concrete pit under pumphouse on WS slope. Originally included in the 1966 O&M manual. FS Date: 7/10/2013

14-inch pipe visible at WS toe below pumphouse.

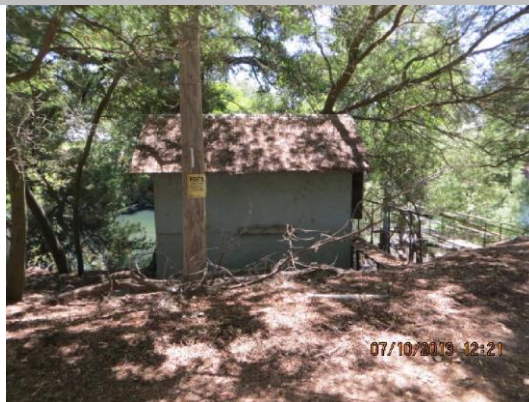
Photo 2 of 3 : UCIP\_SP\_2017\_15663\_26081.jpg

Concrete pumphouse on WS slope.

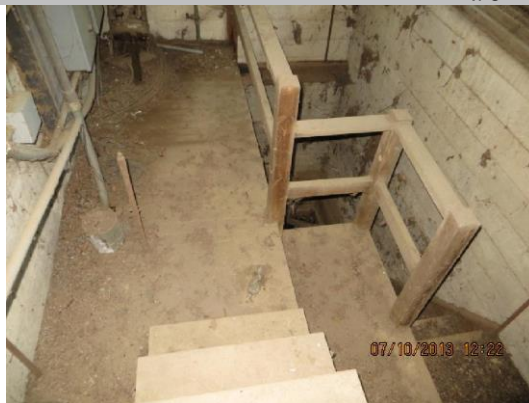
Photo 3 of 3 : UCIP\_SP\_2017\_15663\_26080.jpg

LM Start	8.05	Rating **	M	Issue No.	252 (cont)
LM End	8.05	Issue Type +	En	Location *	LS
Category	Supplemental			GPS Latitude/Longitude	
				Start	End
Item	DWR UCIP Field Study			38.409440 °	38.409440 °
				-121.540928 °	-121.540928 °
DWR ID					
Comment Code					
Inspector Comment					
FS_ID:15663 DS_ID:22868 EP_NO: N/A Repair Type: Non-Urgent Crossing Status: Found UCIP Comments: Pipe abandoned and should be done so properly. FIELD_STRUCT_DESC: *Abandoned* 14-inch pipe through levee 14.4 feet below crown. Gate valve at pump in Concrete pit under pumphouse on WS slope. Originally included in the 1966 O&M manual. FS Date: 7/10/2013

Pump and gate valve assumed to be in bottom of concrete well inside pumphouse.

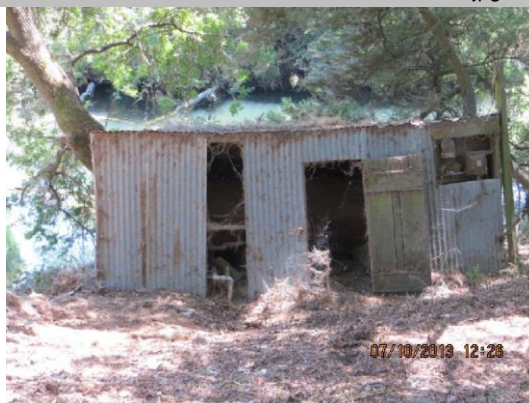
Photo 1 of 2 : UCIP\_SP\_2017\_15664\_26084.jpg

LM Start	8.05	Rating **	M	Issue No.	253
LM End	8.05	Issue Type +	En	Location *	LS
Category	Supplemental			GPS Latitude/Longitude	
				Start	End
Item	DWR UCIP Field Study			38.409488 °	38.409488 °
				-121.540833 °	-121.540833 °
DWR ID					
Comment Code					
Inspector Comment					
FS_ID:15664 DS_ID:22870 EP_NO: N/A Repair Type: Non-Urgent Crossing Status: Found UCIP Comments: Pipe appears abandoned and should be done so properly. FIELD_STRUCT_DESC: 2-inch galvanized iron domestic water pipe through the levee 12.5 feet below the crown. Gate valve and domestic pressure system in pump house on the waterward slope. Originally included in the 1966 O&M manual. FS Date: 7/10/2013

Pipe visible inside pumphouse on WS slope.

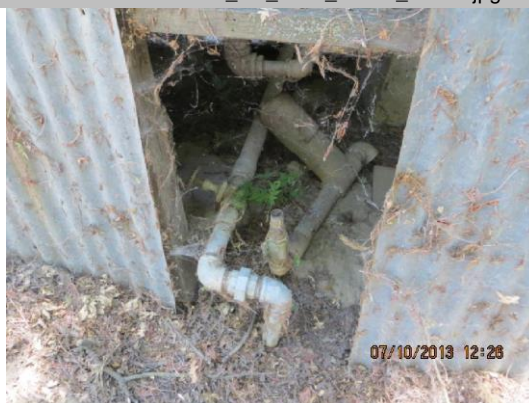
Photo 2 of 2 : UCIP\_SP\_2017\_15664\_26083.jpg

LM Start	8.05	Rating **	M	Issue No.	253 (cont)	
LM End	8.05	Issue Type +	En	Location *	LS	
Category	Supplemental			GPS Latitude/Longitude		
				Start		End
Item	DWR UCIP Field Study			38.409488 °		38.409488 °
				-121.540833 °		-121.540833 °
DWR ID						
Comment Code						
Inspector Comment						
FS_ID:15664						
DS_ID:22870						
EP_NO: N/A						
Repair Type: Non-Urgent						
Crossing Status: Found						
UCIP Comments: Pipe appears abandoned and should be done so properly.						
FIELD_STRUCT_DESC: 2-inch galvanized iron domestic water pipe through the levee 12.5 feet below the crown. Gate valve and domestic pressure system in pump house on the waterward slope. Originally included in the 1966 O&M manual.						
FS Date: 7/10/2013

Pipe visible inside pumphouse on WS slope.

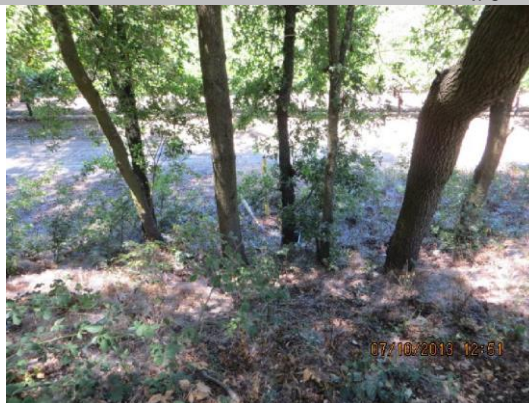
Photo 2 of 3 : UCIP\_SP\_2017\_15685\_26105.jpg

LM Start	8.10	Rating **	M	Issue No.	254 (cont)	
LM End	8.10	Issue Type +	En	Location *	WS	
Category	Supplemental			GPS Latitude/Longitude		
				Start		End
Item	DWR UCIP Field Study			38.409749 °		38.409749 °
				-121.540079 °		-121.540079 °
DWR ID						
Comment Code						
Inspector Comment						
FS_ID:15685						
DS_ID:22871						
EP_NO: 4851						
Repair Type: Non-Urgent						
Crossing Status: Found						
UCIP Comments: Pipe appears to be abandoned and should be done so properly.						
FIELD_STRUCT_DESC: 8-inch pipe through levee 6.2 feet below crown. Gate valve in pump house on the waterward slope, service pole on both slopes (Permit No 4851, 1965). Originally included in the 1966 O&M manual.						
FS Date: 7/10/2013

Possible location for original outlet on LS of Netherlands road.

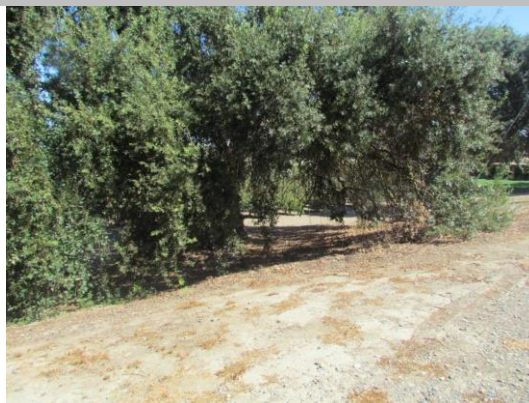
Photo 1 of 1 : SP\_2017\_RD0999\_236\_206\_20170314\_00145.jpg

LM Start	8.22	Rating **	U	Issue No.	206
LM End	8.22	Issue Type +	Ma	Location *	LS
Category	Earthen Levee			GPS Latitude/Longitude	
				Start	End
Item	Trim / Thin Trees			38.409679 °	38.409679 °
				-121.537920 °	-121.537920 °
DWR ID	DWR_RD0999_05_f_2014_206				
Comment Code					
T1 : Trim trees to at least five feet above ground level.					
Inspector Comment

Looking west at untrimmed trees on landward toe.

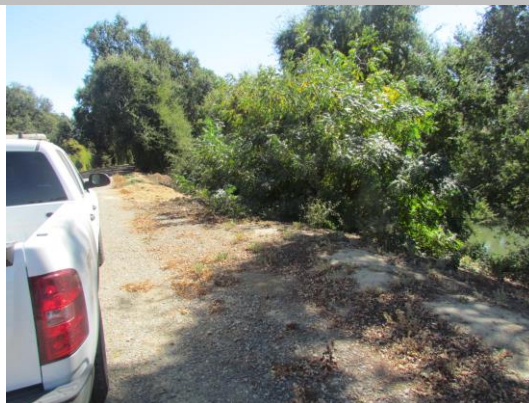
Photo 1 of 1 : SP\_2017\_RD0999\_236\_118\_20170314\_00082.jpg

LM Start	8.22	Rating **	U	Issue No.	118
LM End	8.22	Issue Type +	Ma	Location *	WS
Category	Earthen Levee			GPS Latitude/Longitude	
				Start	End
Item	Trim / Thin Trees			38.409665 °	38.409665 °
				-121.537898 °	-121.537898 °
DWR ID	DWR_RD0999_05_s_2012_118				
Comment Code					
T1 : Trim trees to at least five feet above ground level.					
Inspector Comment

Looking northeast at untrimmed trees on watward slope.

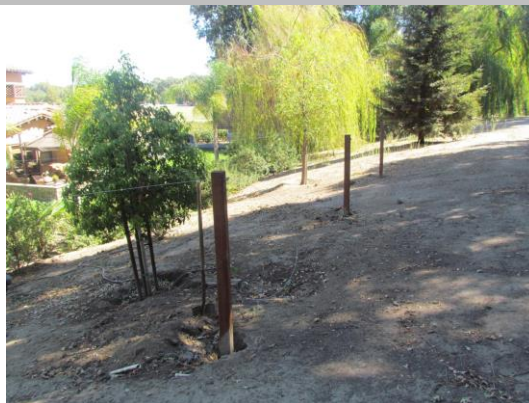
Photo 1 of 2 : SP\_2017\_RD0999\_236\_221\_20170314\_00156.jpg

LM Start	8.27	Rating **	M	Issue No.	221
LM End	8.27	Issue Type +	En	Location *	LS
Category	Earthen Levee			GPS Latitude/Longitude	
				Start	End
Item	Encroachments			38.409468 °	38.409468 °
				-121.537066 °	-121.537066 °
DWR ID	DWR_RD0999_05_f_2016_221				
Comment Code					
PO : Pole					
Inspector Comment					
Landowner installed wooden poles on landward slope to hang lights

Looking east at wooden poles on landward shoulder.

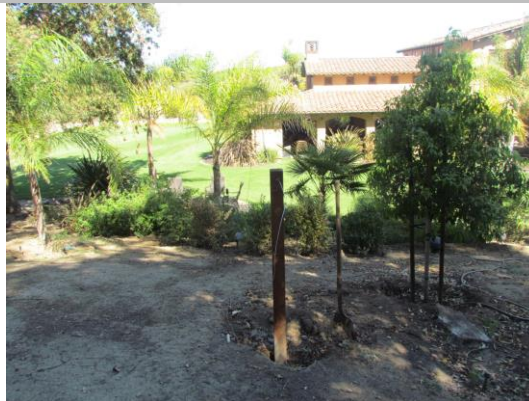
Photo 2 of 2 : SP\_2017\_RD0999\_236\_221\_20170314\_00157.jpg

LM Start	8.27	Rating **	M	Issue No.	221 (cont)	
LM End	8.27	Issue Type +	En	Location *	LS	
Category	Earthen Levee			GPS Latitude/Longitude		
				Start		End
Item	Encroachments			38.409468 °		38.409468 °
				-121.537066 °		-121.537066 °
DWR ID	DWR_RD0999_05_f_2016_221					
Comment Code						
PO : Pole						
Inspector Comment						
Landowner installed wooden poles on landward slope to hang lights

Looking north at wooden pole on landward shoulder.

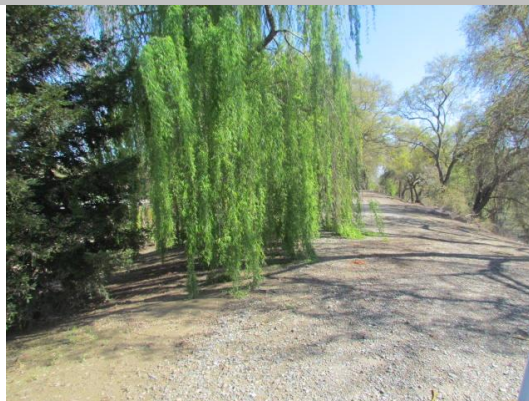
Photo 1 of 1 : SP\_2017\_RD0999\_236\_194\_20170314\_00134.jpg

LM Start	8.29	Rating **	U	Issue No.	194
LM End	8.29	Issue Type +	Ma	Location *	LS
Category	Earthen Levee			GPS Latitude/Longitude	
				Start	End
Item	Trim / Thin Trees			38.409319 °	38.409319 °
				-121.536678 °	-121.536678 °
DWR ID	DWR_RD0999_05_s_2014_194				
Comment Code					
T1 : Trim trees to at least five feet above ground level.					
Inspector Comment					
Trees blocking view of landward slope.

Looking southeast at untrimmed trees on landward slope.

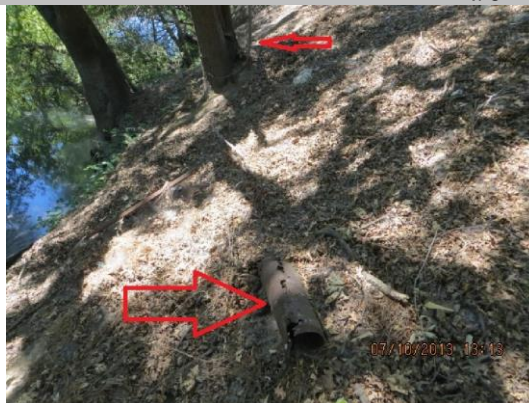
Photo 1 of 3 : UCIP\_SP\_2017\_15686\_26109.jpg

FS\_ID:15686  
DS\_ID:22872  
EP\_NO: N/A  
Repair Type: Non-Urgent  
Crossing Status: Indicator Found  
UCIP Comments: Type of pipe abandonment needs to be verified.  
FIELD\_STRUCT\_DESC: \*Abandoned\* 8-inch pipe through levee 11.7 feet below crown, no control valves. 1.5-inch galvanized iron electrical conduit found on WS slope at oak tree. 8-inch Pipe debris visible on WS slope. Originally included in the 1966 O&M manual.  
FS Date: 7/10/2013

8-inch pipe debris with 1.5-inch electrical conduit visible in background on WS slope.

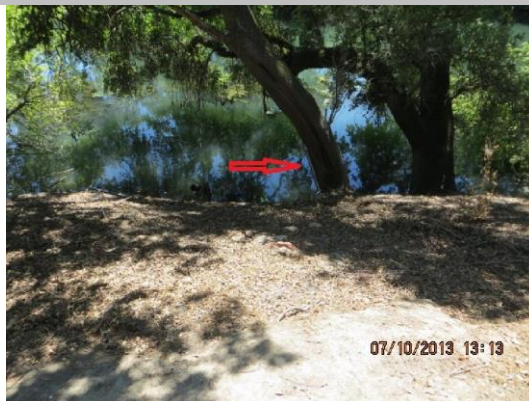
Photo 2 of 3 : UCIP\_SP\_2017\_15686\_26108.jpg

1.5-inch electrical conduit visible on WS slope next to oak.

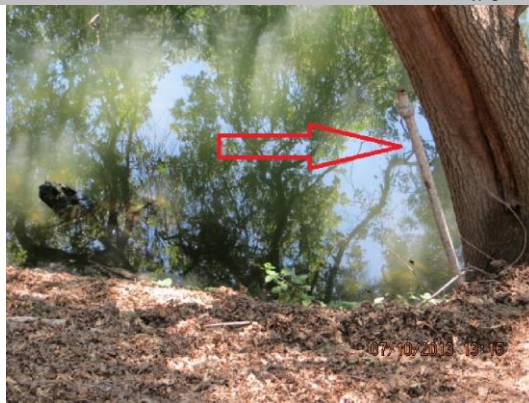
Photo 3 of 3 : UCIP\_SP\_2017\_15686\_26107.jpg

LM Start	8.29	Rating **	M	Issue No.	255 (cont)	
LM End	8.29	Issue Type +	En	Location *	LS	
Category	Supplemental			GPS Latitude/Longitude		
				Start	End	
Item	DWR UCIP Field Study			38.409264 °	38.409264 °	
				-121.536659 °	-121.536659 °	
DWR ID						
Comment Code						
Inspector Comment						
FS_ID:15686						
DS_ID:22872						
EP_NO: N/A						
Repair Type: Non-Urgent						
Crossing Status: Indicator Found						
UCIP Comments: Type of pipe abandonment needs to be verified.						
FIELD_STRUCT_DESC: *Abandoned* 8-inch pipe through levee 11.7						
feet below crown, no control valves. 1.5-inch galvanized iron electrical						
conduit found on WS slope at oak tree. 8-inch Pipe debris visible on						
WS slope. Originally included in the 1966 O&M manual.						
FS Date: 7/10/2013

1.5-inch electrical conduit visible on WS slope next to oak.

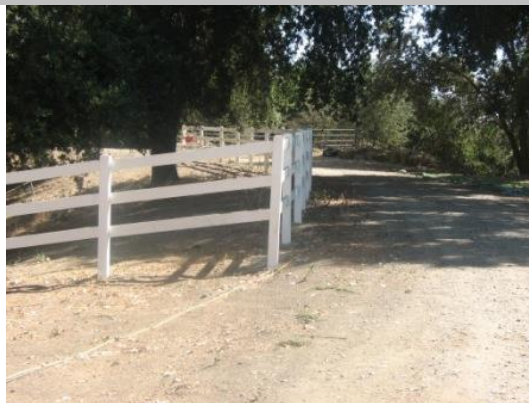
Photo 1 of 1 : SP\_2017\_RD0999\_236\_101\_20170314\_00078.jpg

LM Start	8.39	Rating **	M	Issue No.	101
LM End	8.43	Issue Type +	En	Location *	LS
Category	Earthen Levee			GPS Latitude/Longitude	
				Start	End
Item	Encroachments			38.408586 °	38.408748 °
				-121.534992 °	-121.534437 °
DWR ID	DWR_RD0999_05_s_2012_101				
Comment Code					
FE : Fence					
Inspector Comment					
Fence installed without CVFPB permit in 2008. Fence extends from landside toe to landside shoulder.

New installed unauthorized fence at landside slope and shoulder.

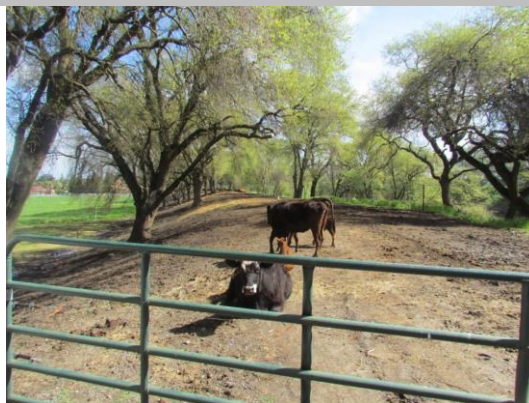
Photo 1 of 6 : SP\_2017\_RD0999\_236\_81\_20170327\_00254.jpg

LM Start	8.42	Rating **	U	Issue No.	81
LM End	8.42	Issue Type +	En	Location *	CR
Category	Earthen Levee			GPS Latitude/Longitude	
				Start	End
Item	Encroachments			38.408612 °	38.408612 °
				-121.534572 °	-121.534572 °
DWR ID	DWR_RD0999_05_f_2015_81				
Comment Code					
FE : Fence					
Inspector Comment					
Landowner blocking access to levee with cattle behind gate, no access.

Looking east at cattle pen across levee crown. (Spring 2017)

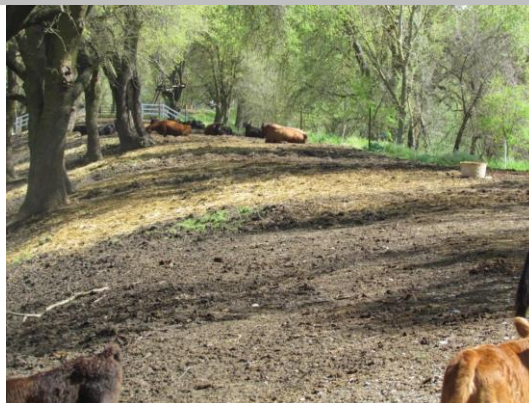
Photo 2 of 6 : SP\_2017\_RD0999\_236\_81\_20170327\_00255.jpg

Looking east at cattle blocking access to levee. (Spring 2017)

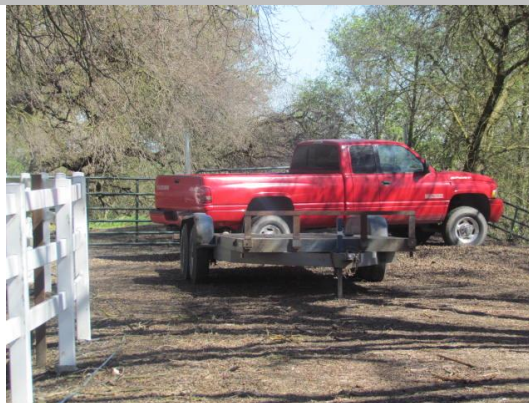
Photo 3 of 6 : SP\_2017\_RD0999\_236\_81\_20170314\_00062.jpg

LM Start	8.42	Rating **	U	Issue No.	81 (cont)	
LM End	8.42	Issue Type +	En	Location *	CR	
Category	Earthen Levee			GPS Latitude/Longitude		
				Start		End
Item	Encroachments			38.408612 °	38.408612 °	
				-121.534572 °	-121.534572 °	
DWR ID	DWR_RD0999_05_f_2015_81					
Comment Code						
FE : Fence						
Inspector Comment						
Landowner blocking access to levee with cattle behind gate, no access.

Looking east at trailer and truck parked across levee. (Spring 2016)

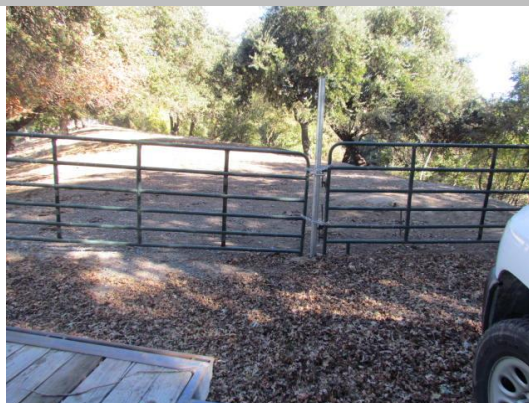
Photo 4 of 6 : SP\_2017\_RD0999\_236\_81\_20170314\_00063.jpg

Looking east at fence and gate across levee crown. (Spring 2015)

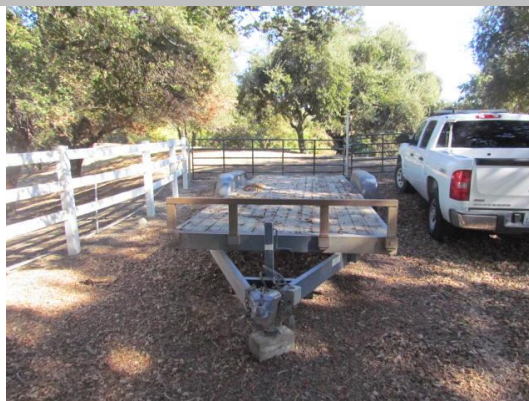
Photo 5 of 6 : SP\_2017\_RD0999\_236\_81\_20170314\_00064.jpg

Looking east at trailer blocking access to the levee. (Spring 2015)

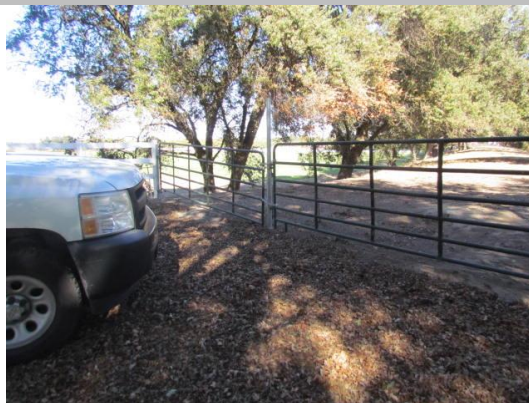
Photo 6 of 6 : SP\_2017\_RD0999\_236\_81\_20170314\_00065.jpg

LM Start	8.42	Rating **	U	Issue No.	81 (cont)	
LM End	8.42	Issue Type +	En	Location *	CR	
Category	Earthen Levee			GPS Latitude/Longitude		
				Start		End
Item	Encroachments			38.408612 °	38.408612 °	
				-121.534572 °	-121.534572 °	
DWR ID	DWR_RD0999_05_f_2015_81					
Comment Code						
FE : Fence						
Inspector Comment						
Landowner blocking access to levee with cattle behind gate, no access.

Looking north at fence and gate across levee crown. (Spring 2014)

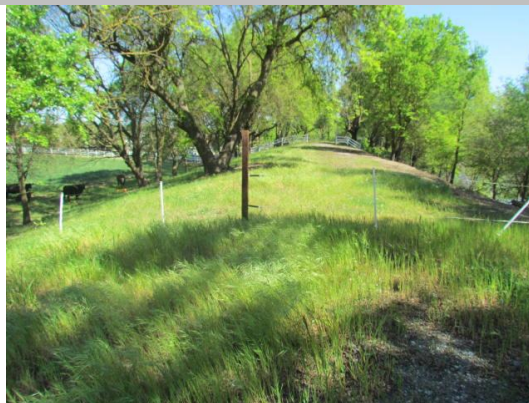
Photo 1 of 1 : SP\_2017\_RD0999\_236\_187\_20170314\_00126.jpg

LM Start	8.50	Rating **	M	Issue No.	187
LM End	8.50	Issue Type +	En	Location *	CR
Category	Earthen Levee			GPS Latitude/Longitude	
				Start	End
Item	Encroachments			38.409395 °	38.409395 °
				-121.533593 °	-121.533593 °
DWR ID	DWR_RD0999_05_s_2015_187				
Comment Code					
FE : Fence					
Inspector Comment					
Landowner installed a electrical fence across levee crown.

Looking east at new electrical fence across levee crown and landward slope. (Spring 2015)

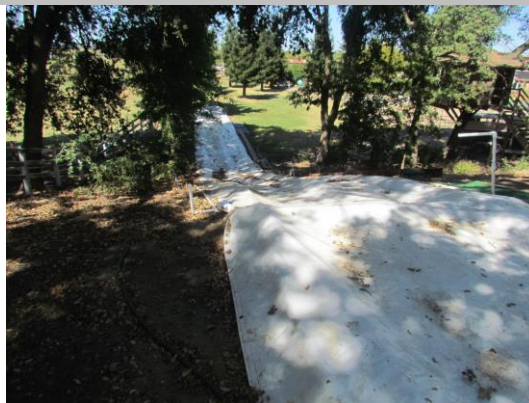
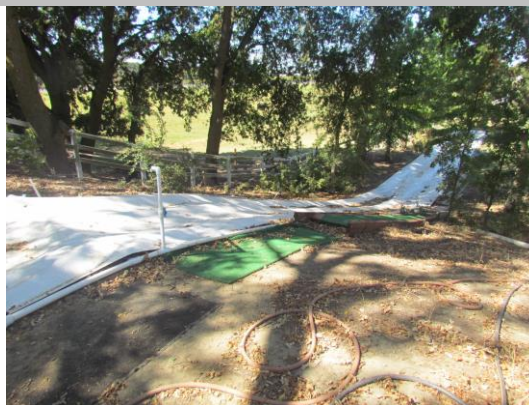
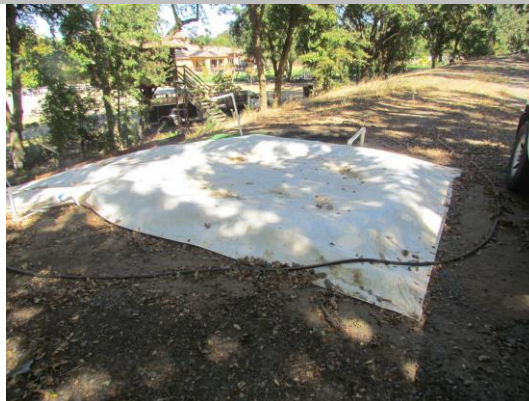
LM Start	8.54	Rating **	M	Issue No.	222
LM End	8.54	Issue Type +	En	Location *	LS
Category	Earthen Levee			GPS Latitude/Longitude	
				Start	End
Item	Encroachments			38.409931 °	38.409931 °
				-121.533033 °	-121.533033 °
DWR ID	DWR_RD0999_05_f_2016_222				
Comment Code					
PL : Pool					
Inspector Comment					
Landowner installed slip and slide and pvc pipes on landward slope.

Looking west at slip and slide on landward slope.

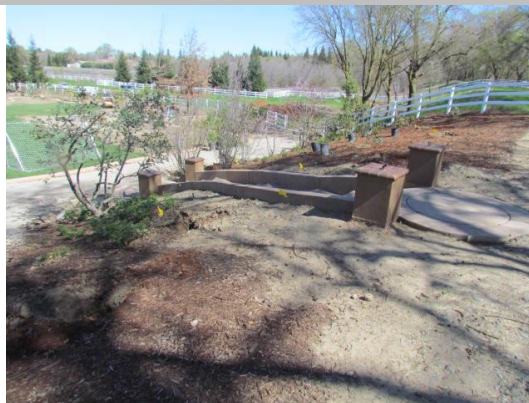
Photo 1 of 2 : SP\_2017\_RD0999\_236\_196\_20170314\_00136.jpg

LM Start	8.58	Rating **	M	Issue No.	196
LM End	8.58	Issue Type +	En	Location *	LS
Category	Earthen Levee			GPS Latitude/Longitude	
				Start	End
Item	Encroachments			38.410279 °	38.410279 °
				-121.532414 °	-121.532414 °
DWR ID	DWR_RD0999_05_s_2014_196				
Comment Code					
ST : Stairway					
Inspector Comment					
Landowner installed concrete stairs and sprinkler and plantings on landside slope without CVFPB permit.

Looking east at concrete stairs, sprinklers and plantings on landward slope.

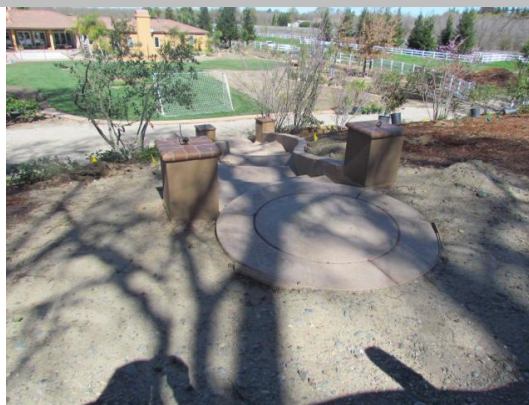
Photo 2 of 2 : SP\_2017\_RD0999\_236\_196\_20170314\_00137.jpg

Looking north at concrete stairs on landward slope.

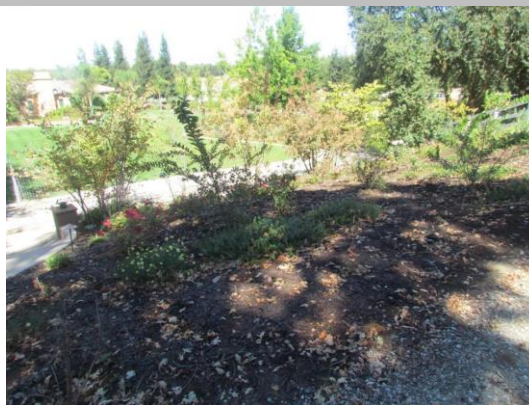
Photo 1 of 1 : SP\_2017\_RD0999\_236\_126\_20170314\_00083.jpg

LM Start	8.59	Rating **	M	Issue No.	126
LM End	8.59	Issue Type +	En	Location *	LS
Category	Earthen Levee			GPS Latitude/Longitude	
				Start	End
Item	Vegetation			38.410283 °	38.410283 °
				-121.532353 °	-121.532353 °
DWR ID	DWR_RD0999_05_s_2012_126				
Comment Code					
V6 : Landscaping					
Inspector Comment

Looking northeast at landscaping on landward slope.

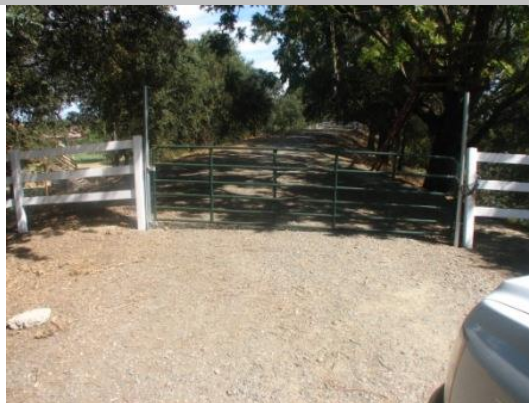
Photo 1 of 2 : SP\_2017\_RD0999\_236\_103\_20170314\_00079.jpg

LM Start	8.59	Rating **	M	Issue No.	103
LM End	8.59	Issue Type +	En	Location *	CR
Category	Earthen Levee			GPS Latitude/Longitude	
				Start	End
Item	Encroachments			38.410332 °	38.410332 °
				-121.532277 °	-121.532277 °
DWR ID	DWR_RD0999_05_s_2012_103				
Comment Code					
FE : Fence					
Inspector Comment

View of fence &amp; gate across levee crown, landside &amp; waterside slope.

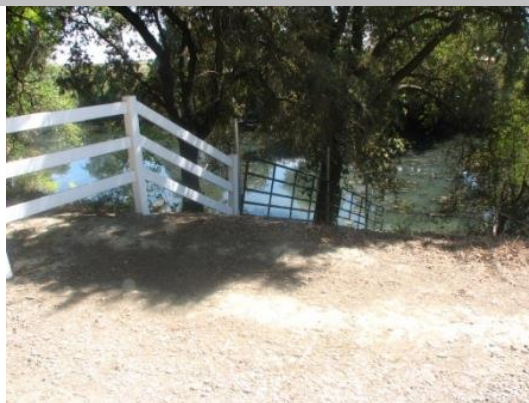
Photo 2 of 2 : SP\_2017\_RD0999\_236\_103\_20170314\_00080.jpg

New unauthorized fence that extend from landside toe to waterside toe.

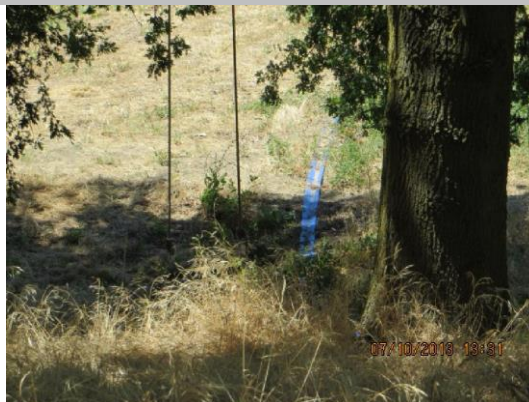
Photo 2 of 2 : UCIP\_SP\_2017\_16345\_27557.jpg

LM Start	8.62	Rating **	M	Issue No.	256
LM End	8.62	Issue Type +	En	Location *	LS
Category	Supplemental			GPS Latitude/Longitude	
				Start	End
Item	DWR UCIP Field Study			38.410531 °	38.410531 °
				-121.531785 °	-121.531785 °
DWR ID					
Comment Code					
Inspector Comment					
FS_ID:16345 DS_ID:23990 EP_NO: N/A Repair Type: Non-Urgent Crossing Status: Found UCIP Comments: Need to determine permit No for crossing or remove it. FIELD_STRUCT_DESC: 3-inch plastic irrigation hose over the levee. Small portable pump on WS toe. FS Date: 7/10/2013

Plastic hose visible on LS toe.

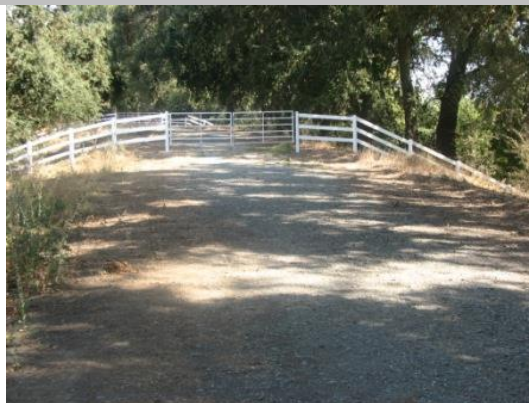
Photo 1 of 1 : SP\_2017\_RD0999\_236\_104\_20170314\_00081.jpg

LM Start	8.63	Rating **	M	Issue No.	104
LM End	8.63	Issue Type +	En	Location *	CR
Category	Earthen Levee			GPS Latitude/Longitude	
				Start	End
Item	Encroachments			38.410617 °	38.410617 °
				-121.531694 °	-121.531694 °
DWR ID	DWR_RD0999_05_s_2012_104				
Comment Code					
FE : Fence					
Inspector Comment

New unauthorized fence and gate that extends from landside toe across levee crown to waterside toe.

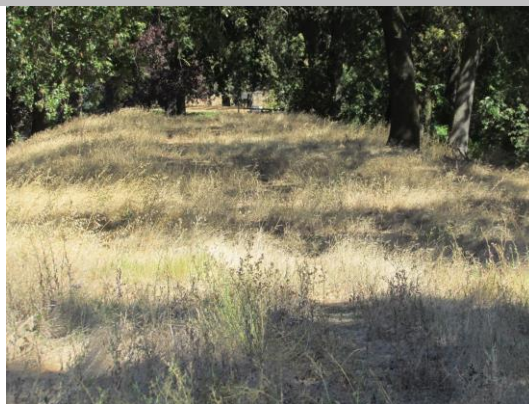
Photo 1 of 1 : SP\_2017\_RD0999\_236\_223\_20170314\_00161.jpg

LM Start	8.64	Rating **	M	Issue No.	223
LM End	8.72	Issue Type +	Ma	Location *	CR
Category	Earthen Levee			GPS Latitude/Longitude	
				Start	End
Item	Vegetation			38.410696 °	38.411560 °
				-121.531584 °	-121.530479 °
DWR ID	DWR_RD0999_05_f_2016_223				
Comment Code					
V9 : Keep the crown roadway free of vegetation.					
Inspector Comment					
Control growth on levee crown

Looking east at overgrowth on levee crown.

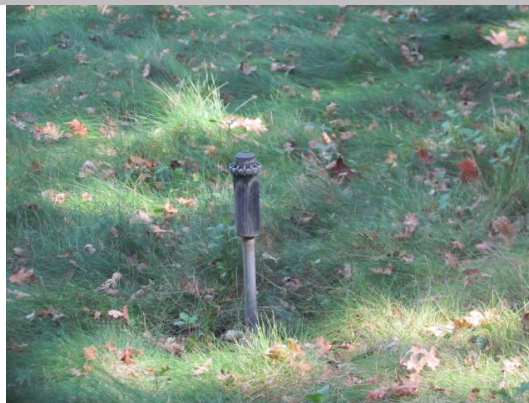
Photo 1 of 1 : SP\_2017\_RD0999\_236\_134\_20170314\_00091.jpg

LM Start	8.73	Rating **	M	Issue No.	134
LM End	8.82	Issue Type +	En	Location *	LS
Category	Earthen Levee			GPS Latitude/Longitude	
				Start	End
Item	Encroachments			38.411577 °	38.412619 °
				-121.530375 °	-121.529691 °
DWR ID	DWR_RD0999_05_f_2012_134				
Comment Code					
LI : Landscape Irrigation					
Inspector Comment					
Sprinklers on landward and waterward shoulder.

Looking at one of several sprinklers on waterward and landward slope.

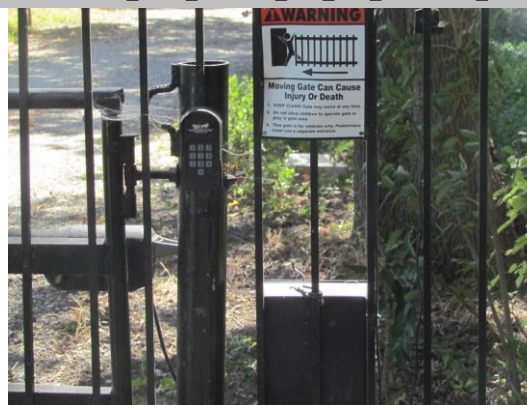
Photo 1 of 2 : SP\_2017\_RD0999\_236\_224\_20170314\_00162.jpg

Looking at code pad on right side of gate.

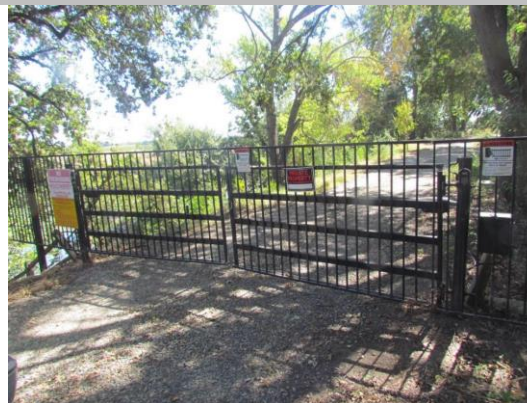
Photo 2 of 2 : SP\_2017\_RD0999\_236\_224\_20170314\_00163.jpg

Looking west at code pad on right side of gate.

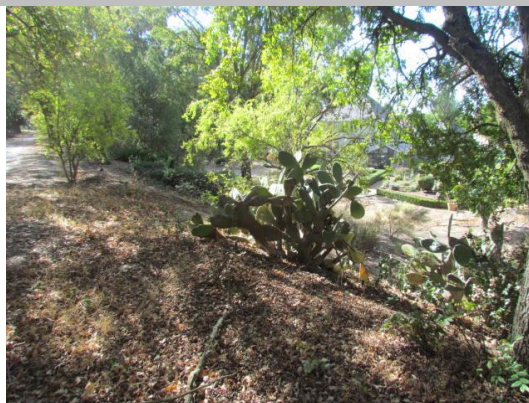
Photo 1 of 1 : SP\_2017\_RD0999\_236\_127\_20170314\_00084.jpg

LM Start	8.90	Rating **	M	Issue No.	127
LM End	8.92	Issue Type +	En	Location *	LS
Category	Earthen Levee			GPS Latitude/Longitude	
				Start	End
Item	Vegetation			38.413780 °	38.414138 °
				-121.529727 °	-121.529772 °
DWR ID	DWR_RD0999_05_s_2012_127				
Comment Code					
V6 : Landscaping					
Inspector Comment					
Cactus and other plants and sprinklers on landward slope.

Looking west at cactus and other vegetation on landward slope.

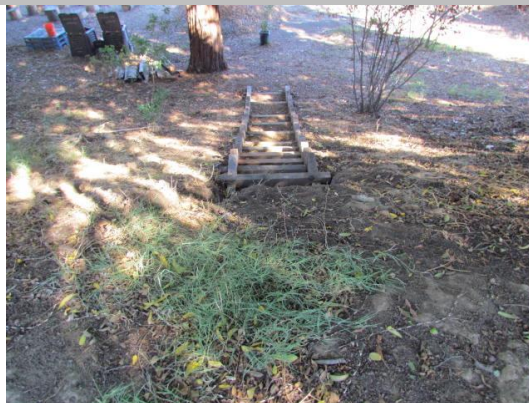
Photo 1 of 1 : SP\_2017\_RD0999\_236\_200\_20170314\_00139.jpg

LM Start	9.14	Rating **	M	Issue No.	200
LM End	9.14	Issue Type +	En	Location *	LS
Category	Earthen Levee			GPS Latitude/Longitude	
				Start	End
Item	Encroachments			38.415787 °	38.415787 °
				-121.527437 °	-121.527437 °
DWR ID	DWR_RD0999_05_f_2015_200				
Comment Code					
ST : Stairway					
Inspector Comment					
Landowner installed stairs on landward slope without permit.

Looking north stairs on landward slope.

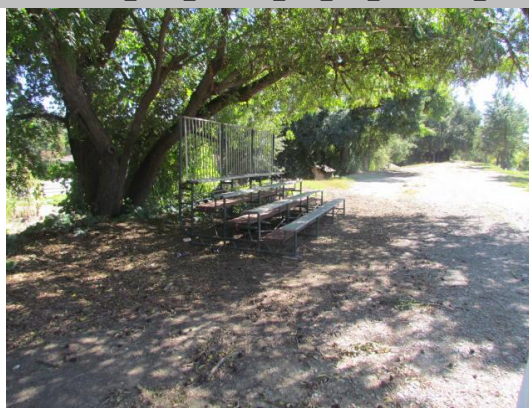
Photo 1 of 1 : SP\_2017\_RD0999\_236\_158\_20170314\_00109.jpg

LM Start	9.15	Rating **	M	Issue No.	158
LM End	9.15	Issue Type +	En	Location *	LS
Category	Earthen Levee			GPS Latitude/Longitude	
				Start	End
Item	Encroachments			38.415709 °	38.415709 °
				-121.527393 °	-121.527393 °
DWR ID	DWR_RD0999_05_f_2013_158				
Comment Code					
EQ : Equipment					
Inspector Comment					
Landowner has placed bleacher on landward shoulder.

Looking northeast at bleacher stored on landward shoulder.

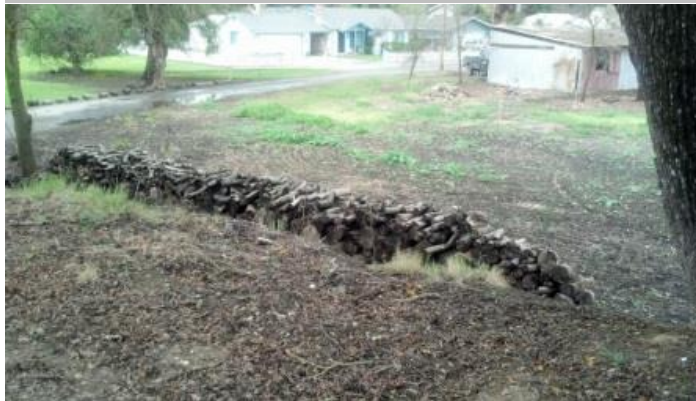
Photo 1 of 2 : SP\_2017\_RD0999\_236\_145\_20170314\_00095.jpg

LM Start	9.44	Rating **	M	Issue No.	145
LM End	9.44	Issue Type +	En	Location *	LS
Category	Earthen Levee			GPS Latitude/Longitude	
				Start	End
Item	Encroachments			38.413755 °	38.413755 °
				-121.523723 °	-121.523723 °
DWR ID	DWR_RD0999_05_s_2013_145				
Comment Code					
FW : Firewood					
Inspector Comment					
Firewood stockpile at landward toe next to ramp.

Looking north at firewood piled at landside toe.

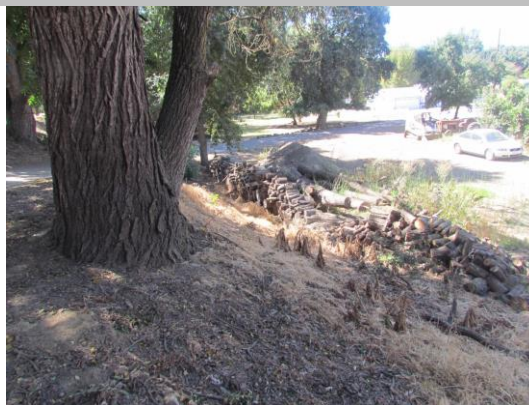
Photo 2 of 2 : SP\_2017\_RD0999\_236\_145\_20170314\_00096.jpg

Looking northwest at firewood at landward toe.
